# Aquatic Plant Survey Results and Management Strategies and Aquatic Invasive Species Prevention Strategies for Lake Wausau in Marathon County, Wisconsin

December 2017

This report was prepared by staff from Golden Sands RC&D, Inc. for the Lake Wausau Association and the Wisconsin Department of Natural Resources. Funding for the study and plan were provided through grants from the Wisconsin Department of Natural Resources and Lake Wausau Association.

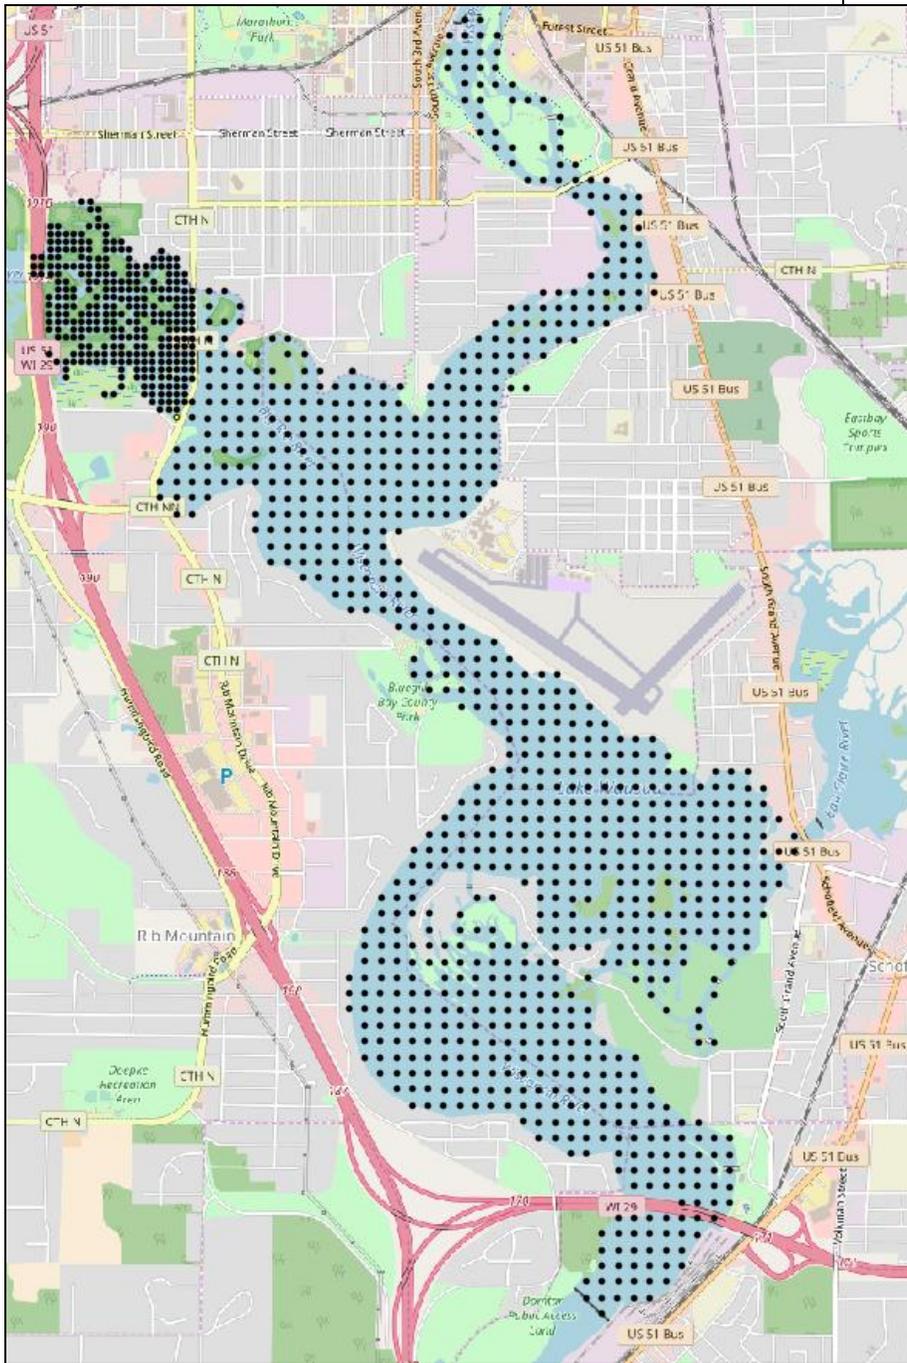
Figure 1. Display of grid points used in the Rib River section and Lake Wausau sections of the 2012 and 2017 aquatic plant surveys. For safety purposes, points displayed below Hwy 29 were omitted from the survey.

The WDNR's point-intercept survey methodologies were used in all of the surveys. Survey points were generated by WDNR staff and to ensure a good representation of the aquatic plant community, the grid was re-oriented by WDNR biologists for maximum coverage. Different grid sizes were used to accommodate the variation in channel size within the flowage; a 45 m grid in the Rib River section and a 90 m grid in the Lake Wausau section (Figure 1). Points identified downstream of the dam were omitted from the survey. GPS units and field maps were used to navigate to the survey sites. At each site, rake heads affixed to extendable poles were lowered from the side of the boat to acquire depth measures, estimates of sediment type, and collect the aquatic plant samples.

inaccessible because their location was on land or in water with depths too shallow to navigate. In total, 684 sites were sampled during the CLP survey; 164 in the Rib River section and 520 in the Lake Wausau section. During the full survey, 134 sites were sampled in the Rib River section and 654 in the Lake Wausau section.

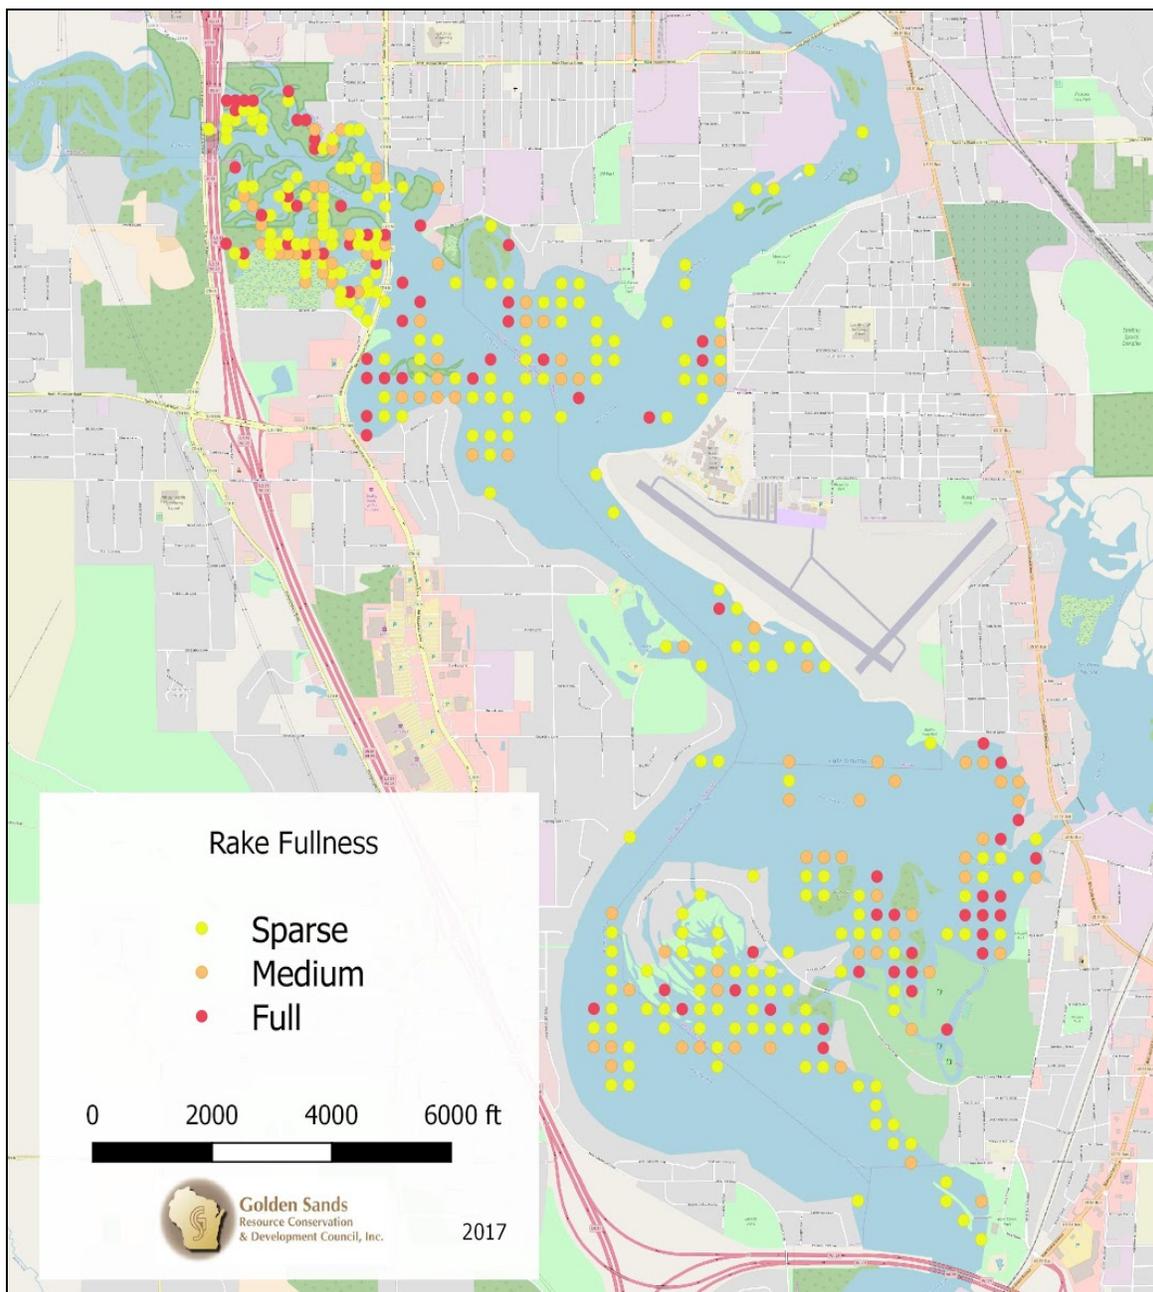
Figure 2 . Aquatic plant density in Lake Wausau during the summer 2017 aquatic plant survey.

The presence of aquatic plants is non-uniform across Lake Wausau. In many areas, especially where water depths are greater than 8 feet, few if any plants grow. The density of aquatic plant growth is also intermittent in the flowage. **Figure 2** shows the rake fullness for all of the vegetated sites in the 2017 Lake Wausau survey, which was based on the amount of plant material on the sampling rake head.

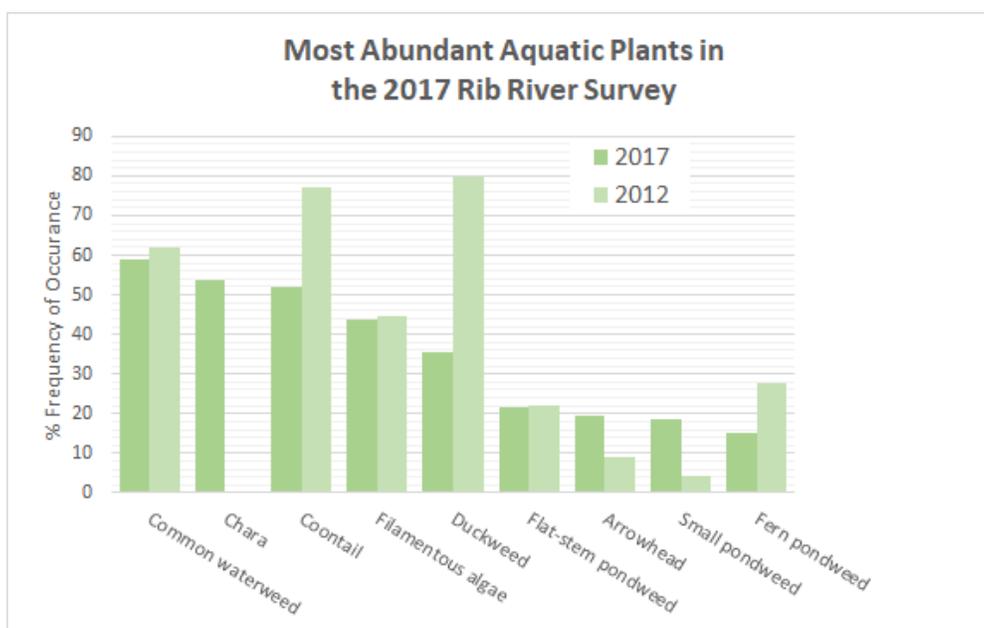
Figure 3. Species of abundant aquatic plants identified during the 2017 survey in the Rib River section.

The most frequently found aquatic plants in 2017 were common waterweed, chara, coontail, filamentous algae, duckweed, flat stem pondweed, arrowhead, small pondweed, and fern pondweed. Comparison of these species with their frequency found in the 2012 survey are displayed in Figure 3.

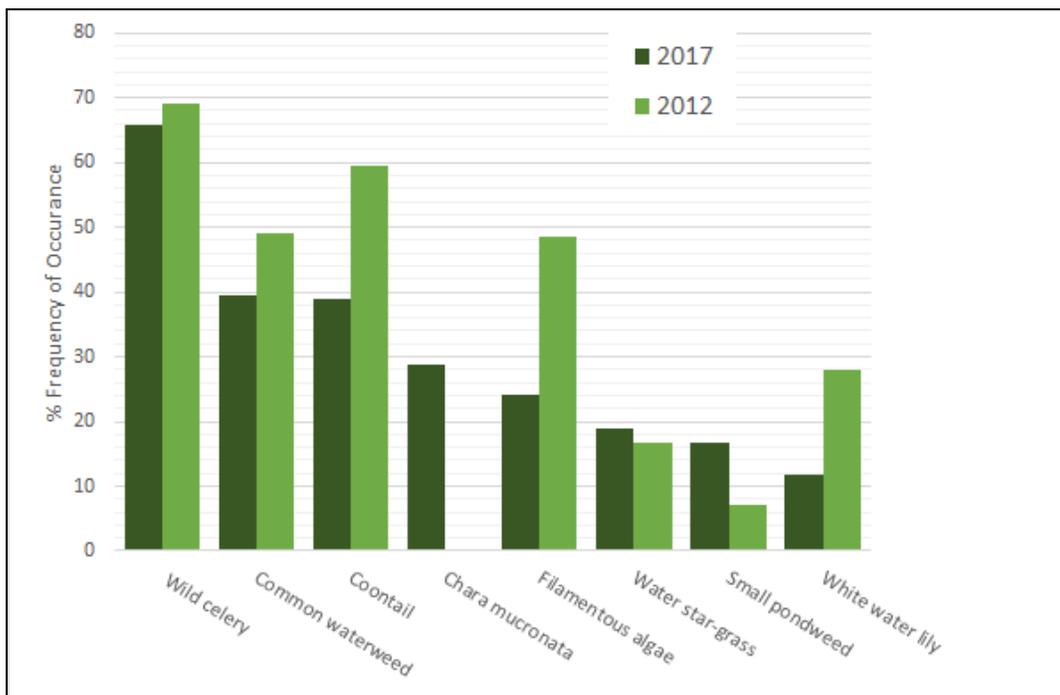
Figure 4. Species of abundant aquatic plants identified during the 2017 survey in the Lake Wausau section.

The aquatic plants found with the greatest frequency in 2017 included wild celery, common waterweed, coontail, muskgrass, filamentous algae, water star-grass, small pondweed, and white water lily. The percent of sites these plants were found at are displayed in Figure 4 for 2017 and 2012.

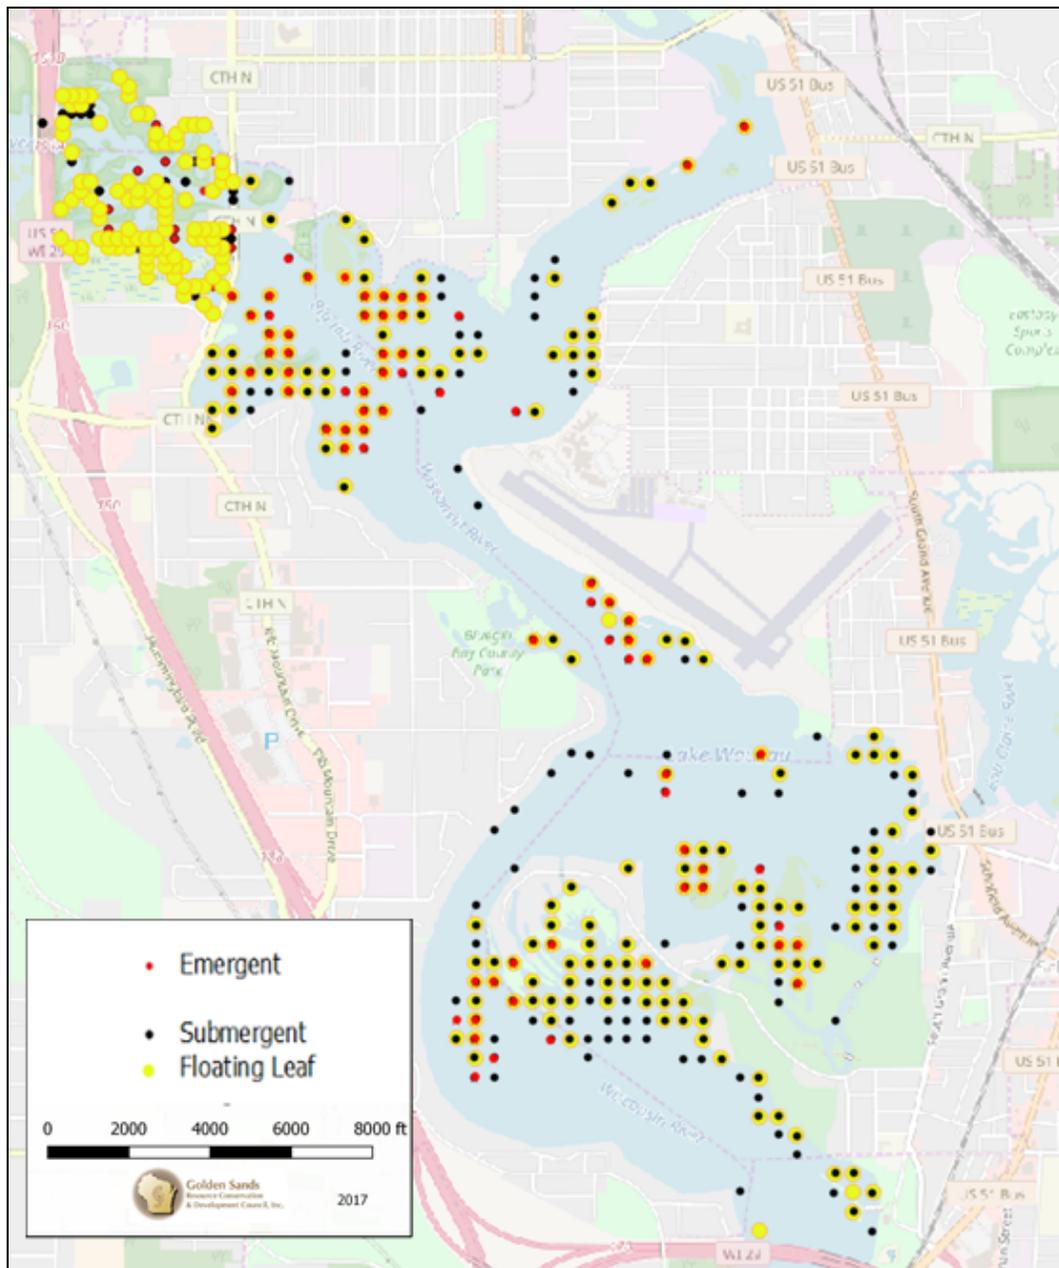
Figure 5. Location of submergent, emergent, and floating-leaf plants identified during the Lake Wausau aquatic plant survey conducted in summer 2017.

While all aquatic plants provide the structure that makes up the majority of habitat within Lake Wausau, different types of aquatic plants provide habitat for different animals or parts of their life cycles. The location of the plants also plays a role in the types of animals that utilize the habitat they provide. Young fish, frogs, and birds generally use shallow habitat that is often found near shore. Except when predating on smaller fish, larger fish typically hide amongst aquatic plants and woody structure in the cooler, deeper water. Large floating-leaf species provide cooler water near shore during warm periods of the summer. Emergent species also flourish in shallow water and provide excellent habitat for the base of the food chain, including attached forms of algae and zooplankton. These foods attract young fish, aquatic forms of insects, and their predators such as juvenile and small fish species. The types of aquatic plants found during the 2017 survey are shown in [Figure 5](#).

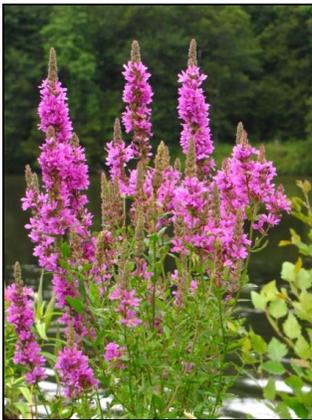
### Purple loosestrife

Purple loosestrife inhabits wet shorelands around Lake Wausau. This perennial plant was originally brought to Wisconsin for use in flower beds and landscaping. Each plant produces thousands of seeds, having the ability to reproduce quickly and outcompete many native wetland species. Its purple steepled flower heads resemble other native species so it is important to learn the difference before taking steps to eliminate the plant.

Individual plants and their roots can be removed by hand. For larger populations, bio-control is frequently used in the management of purple loosestrife. Purple loosestrife beetles, *Galerucella*, can be collected from the wild or obtained through the WDNR. The starter populations of beetles are bred and released into the purple loosestrife population. Although the beetles do not kill the plants, they reduce flowering, seed production and overall height of the plants. The shorter plants allow native species to successfully compete for sunlight and nutrients. Domtar and other local efforts already conduct some purple loosestrife management on Lake Wausau but LWA could enhance these efforts. Training and assistance is available through the local AIS Coordinator or Golden Sands RC&D Council, Inc.

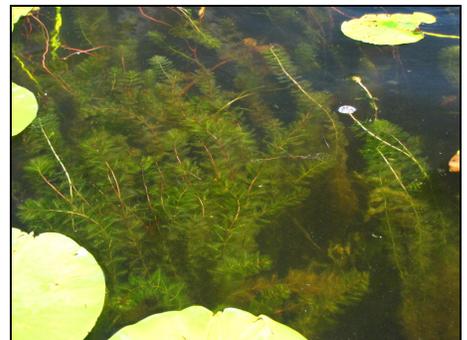
### Eurasian watermilfoil (EWM)

EWM is likely the best known AIS in Wisconsin because it has become a nuisance in many lakes throughout the state. EWM is a perennial aquatic plant that grows up to the water surface to flower, become pollinated, and produce seeds. When it grows in dense stands, the plant parts at the surface can intertwine and become mats, making navigation difficult and making feeding by predatory fish nearly impossible. New EWM plants

can grow from seeds and fragments of the plant. Fragmentation can occur when plant parts are broken up by motor propellers, improper removal techniques, and by natural means in the fall.

Fortunately, the EWM in Lake Wausau has not been behaving aggressively and is quite sparse where it has been observed (Figure 6). EWM was noted at 15 sites in the Rib River section and 47 sites in the Lake Wausau section; the majority were visual observations.

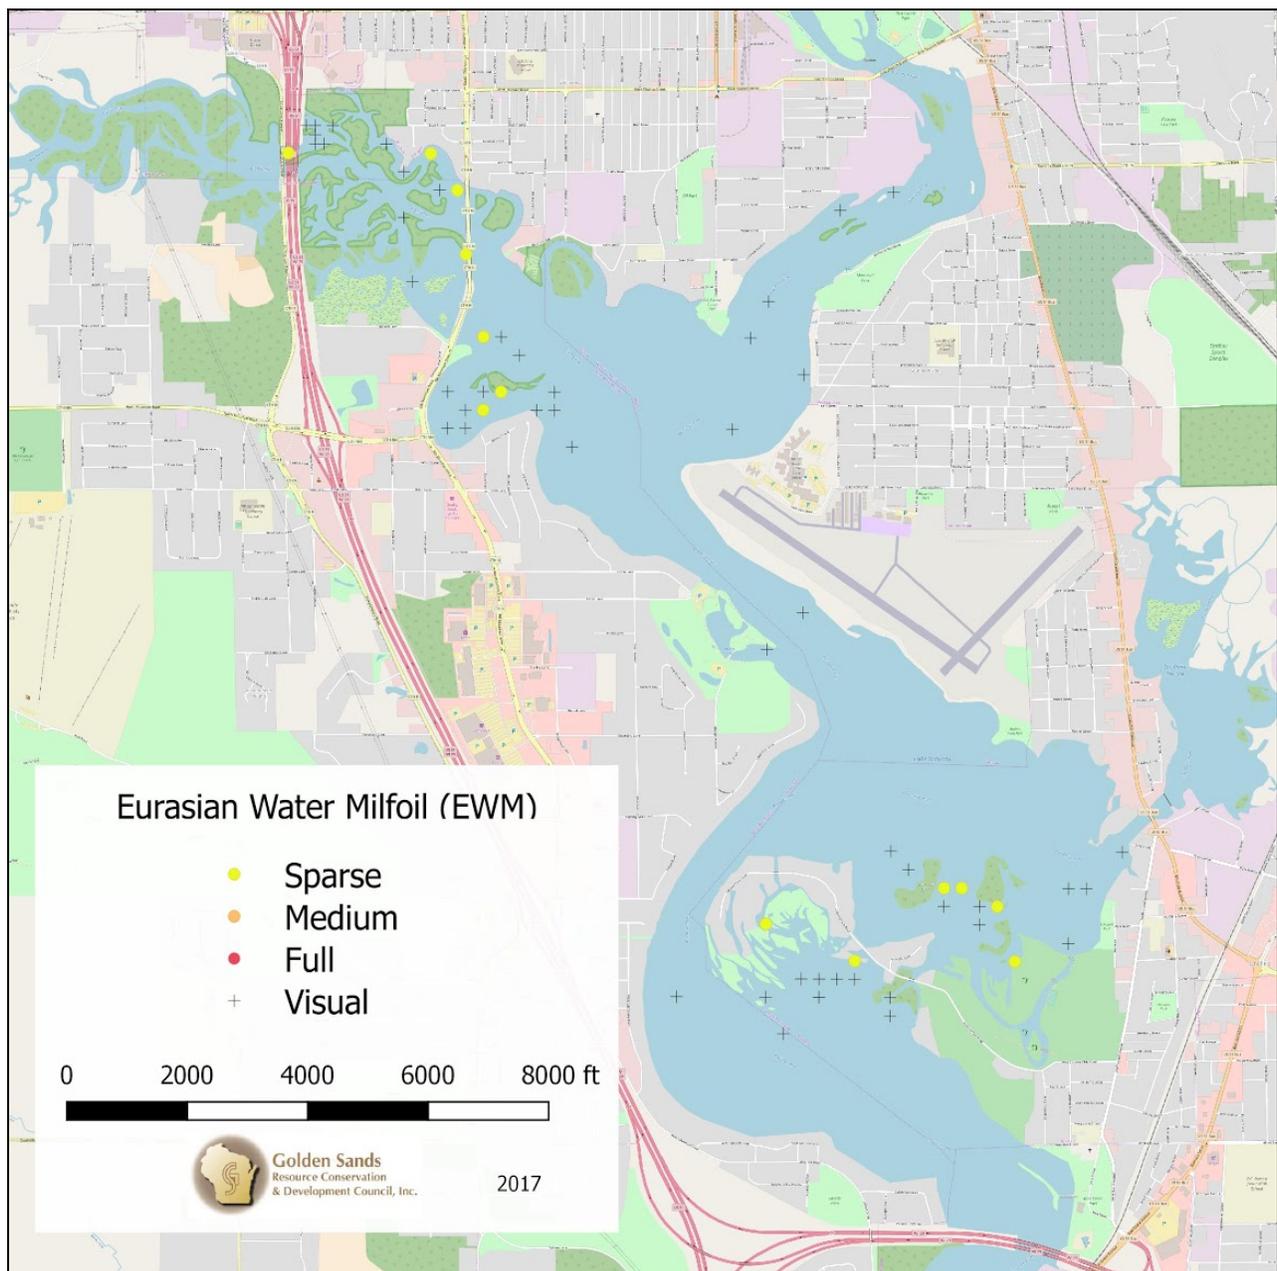
Figure 6. Location and abundance of EWM in Lake Wausau during the summer 2017 survey.

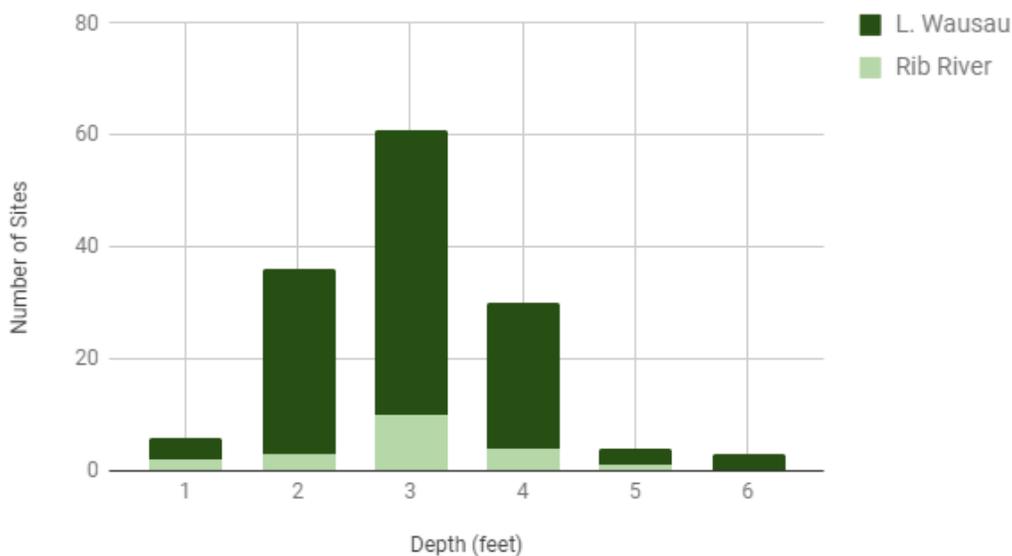
Figure 7. Depths of CLP in Lake Wausau. June 2017.

During the June survey, CLP was found at 140 sites; 120 in the Lake Wausau section and 20 in the Rib River section. While this may seem like a lot of sites, the average rake fullness was 1.2 (sparse). The majority of CLP plants or plant beds were sparse to moderate in density. Only five sites had dense growth. CLP plants occurred in water depths ranging from one to six feet, with the majority in two to four feet of water (Figure 7). Any harvesting activities should focus on the areas with the greatest density in areas that would result in water quality issues or nuisance to recreation.

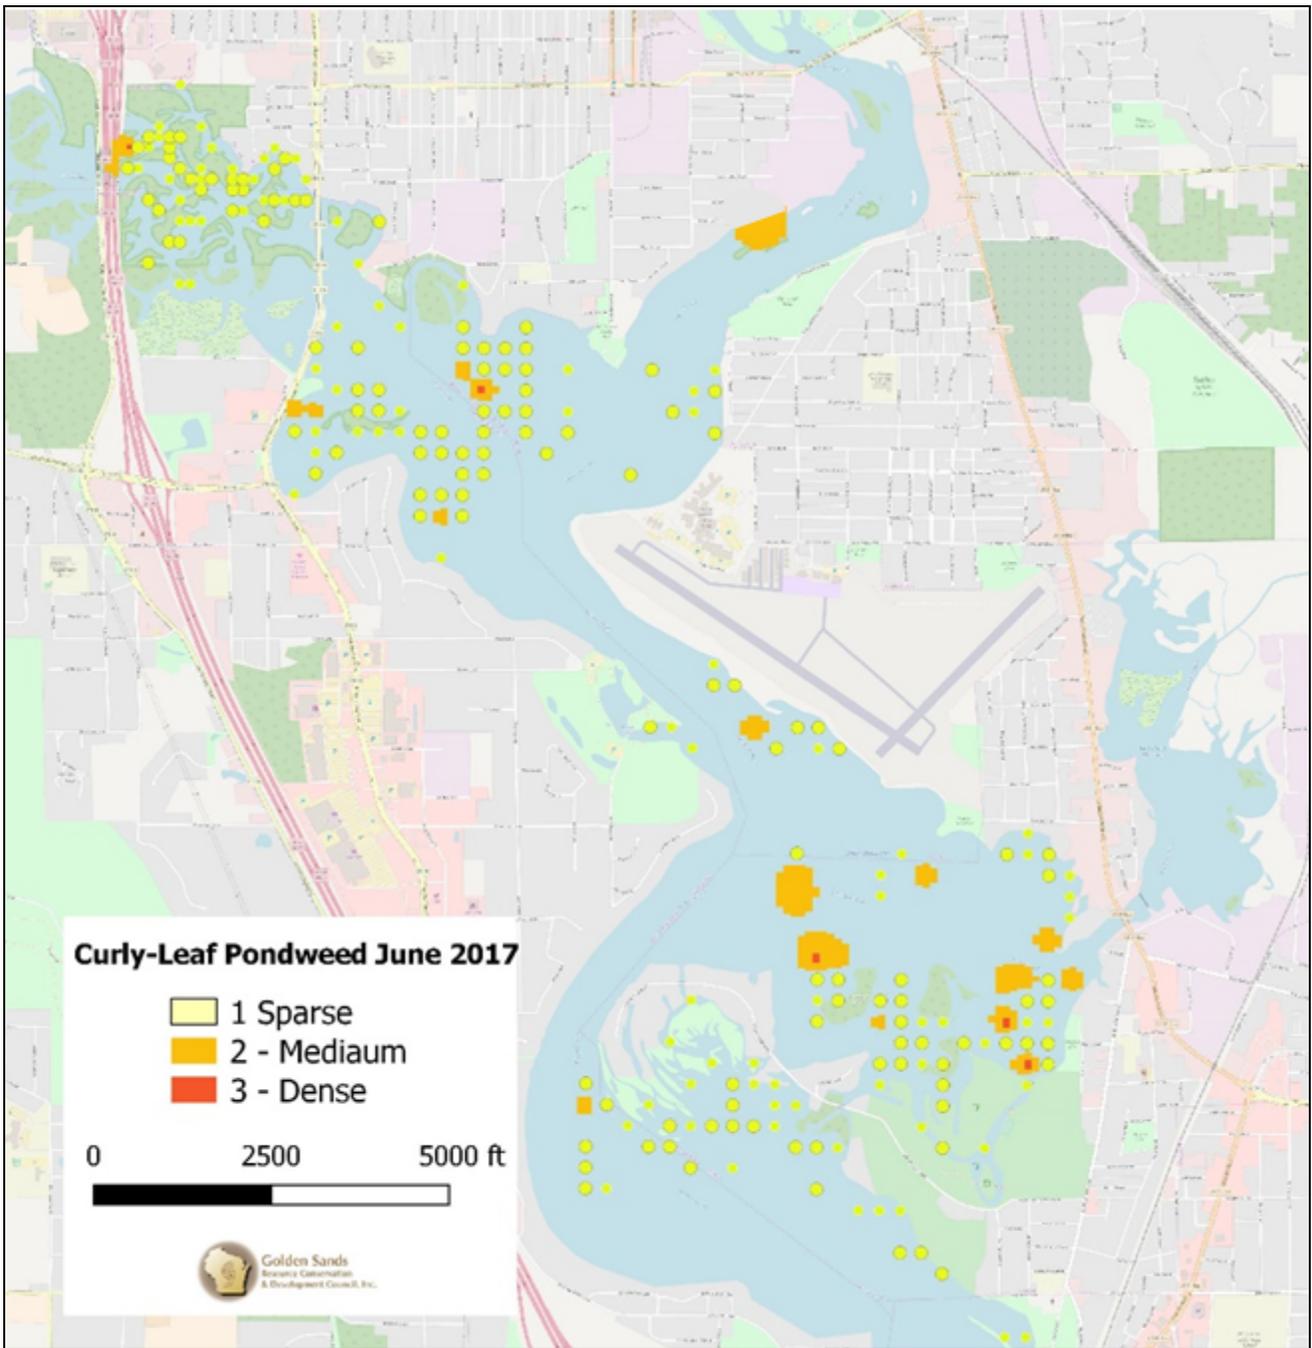
Figure 8 . Location and abundance of CLP in Lake Wausau during the June 2017 survey.

CLP was also present during the survey conducted in the summer, but as would be expected, to a lesser extent. It was observed on 15 occasions in the Rib River section and 23 occurrences in the Lake Wausau section; most were visual observations (Figure 8).

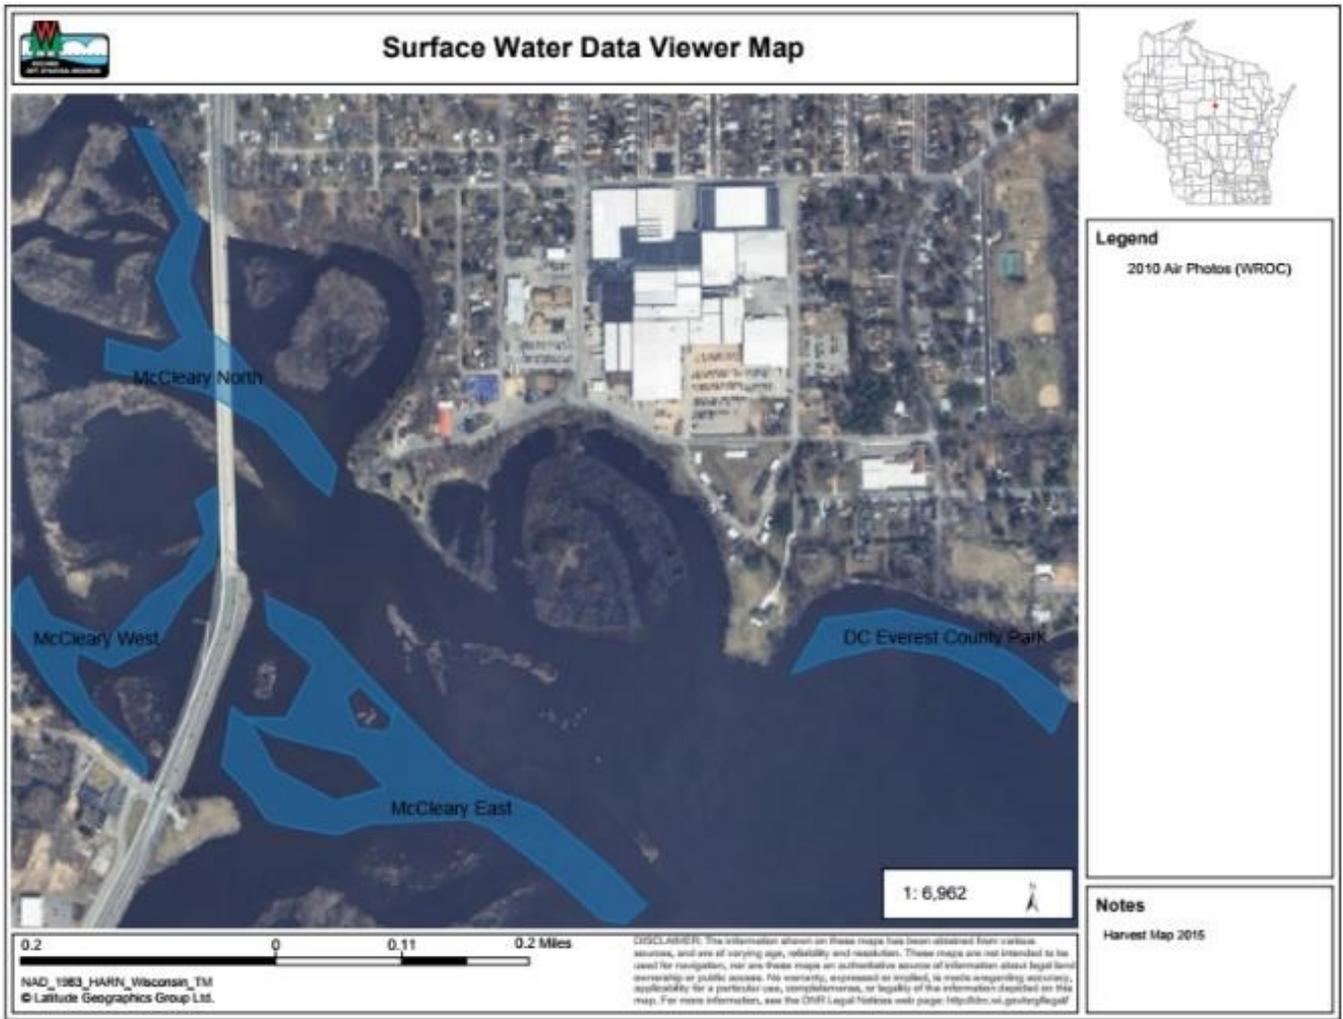
Figure 9. CLP harvesting areas near County Highway N in Lake Wausau.

LWA has worked with staff from WDNR and UWSP to identify the locations where harvesting is most desirable. Because of the lifecycle of CLP, harvesting will achieve the greatest benefits if conducted when plants are at maximum growth, before senescence begins, which typically occurs in early June. Harvesting has been permitted at specified locations in the flowage that have water depths that are sufficient to prevent the disturbance of sediment by the harvesting equipment. Maps of the permitted locations are displayed in **Figures 9-11** and can be found on the WDNR Surface Water Data Viewer. A skimmer can be used to remove floating plant fragments. The nutrient-rich cut plant material should be disposed of on land and away from shorelands and wetlands.

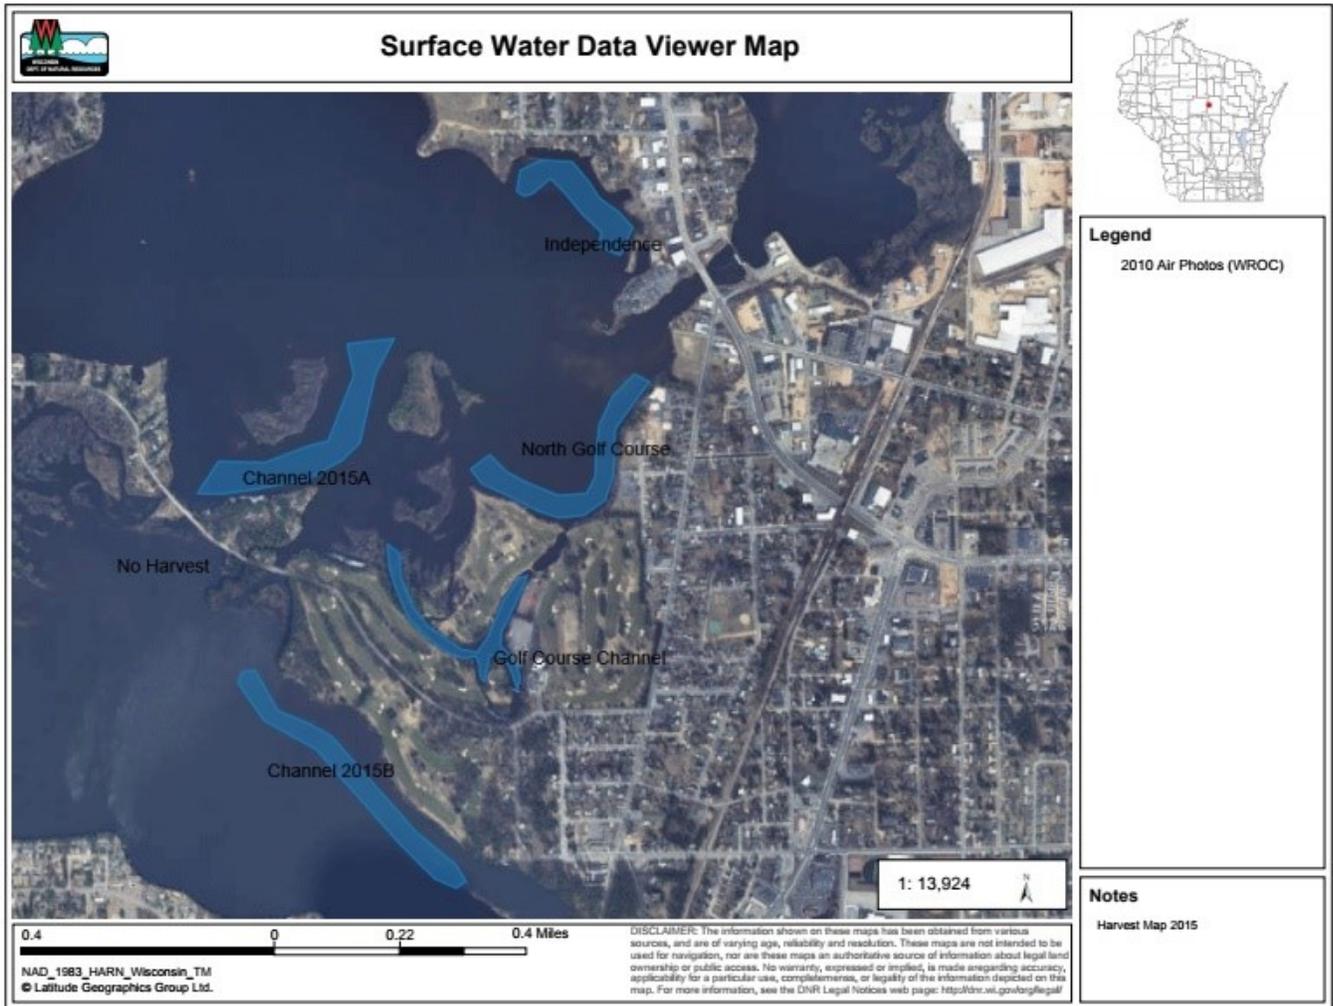
Figure 10. CLP harvesting areas near the islands Lake Wausau.

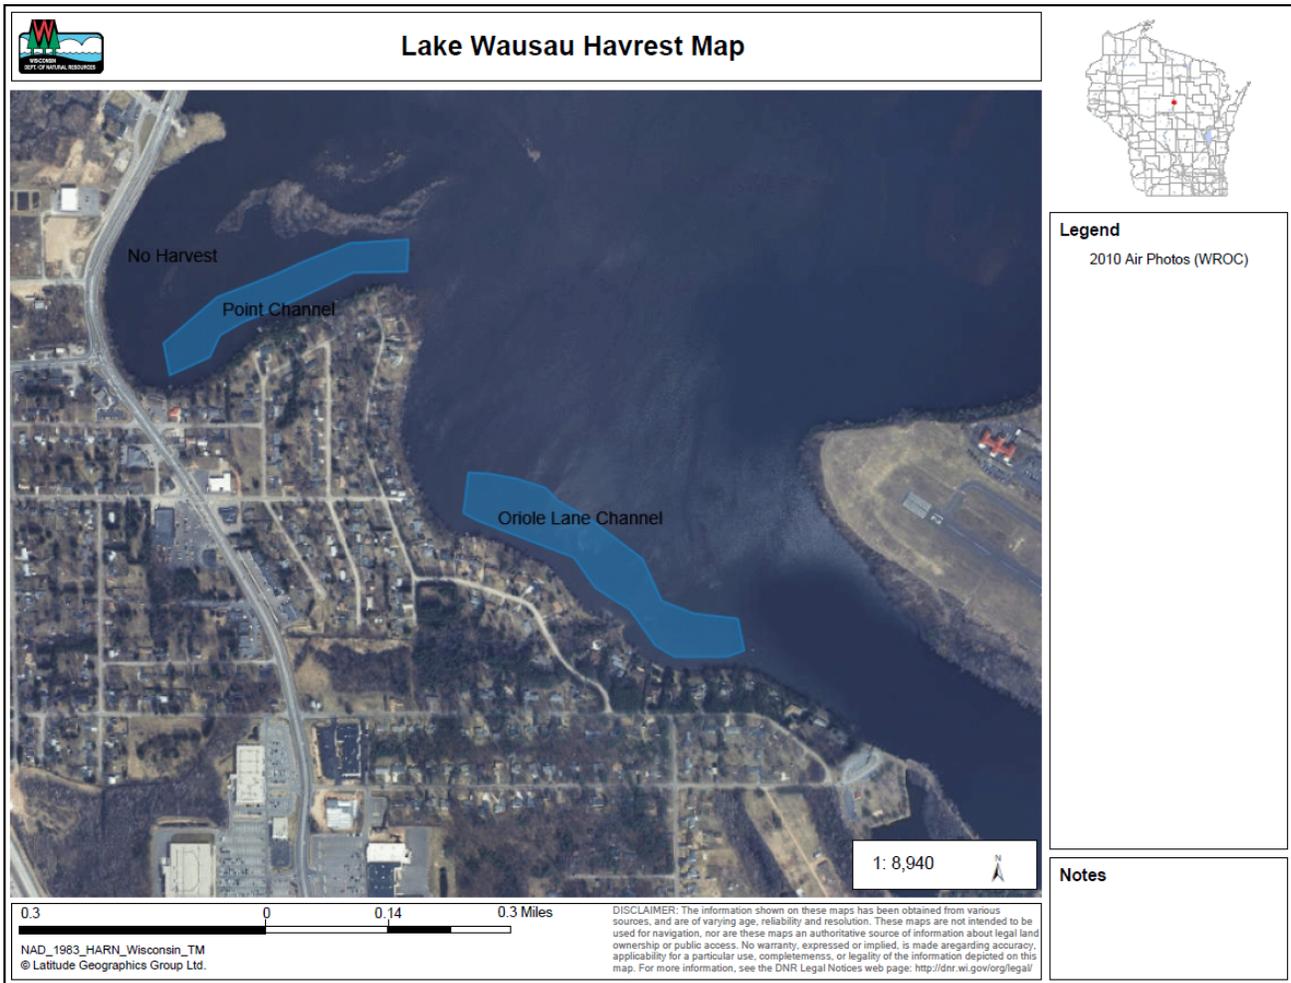
Figure 11. CLP harvesting areas on the western side of Lake Wausau.
